DOCUMENT NO. C8041-PR-024

INVESTIGATION OF INERTIA-WELDING PROCESS FOR APPLYING GILDING
METAL ROTATING BANDS TO PROJECTILE, 155-MM, M483A1

JULY 1978

FINAL TECHNICAL REPORT FOR PERIOD 29 MARCH 1976 - 31 MARCH 1978
CONTRACT DAAA25-76-C-0345

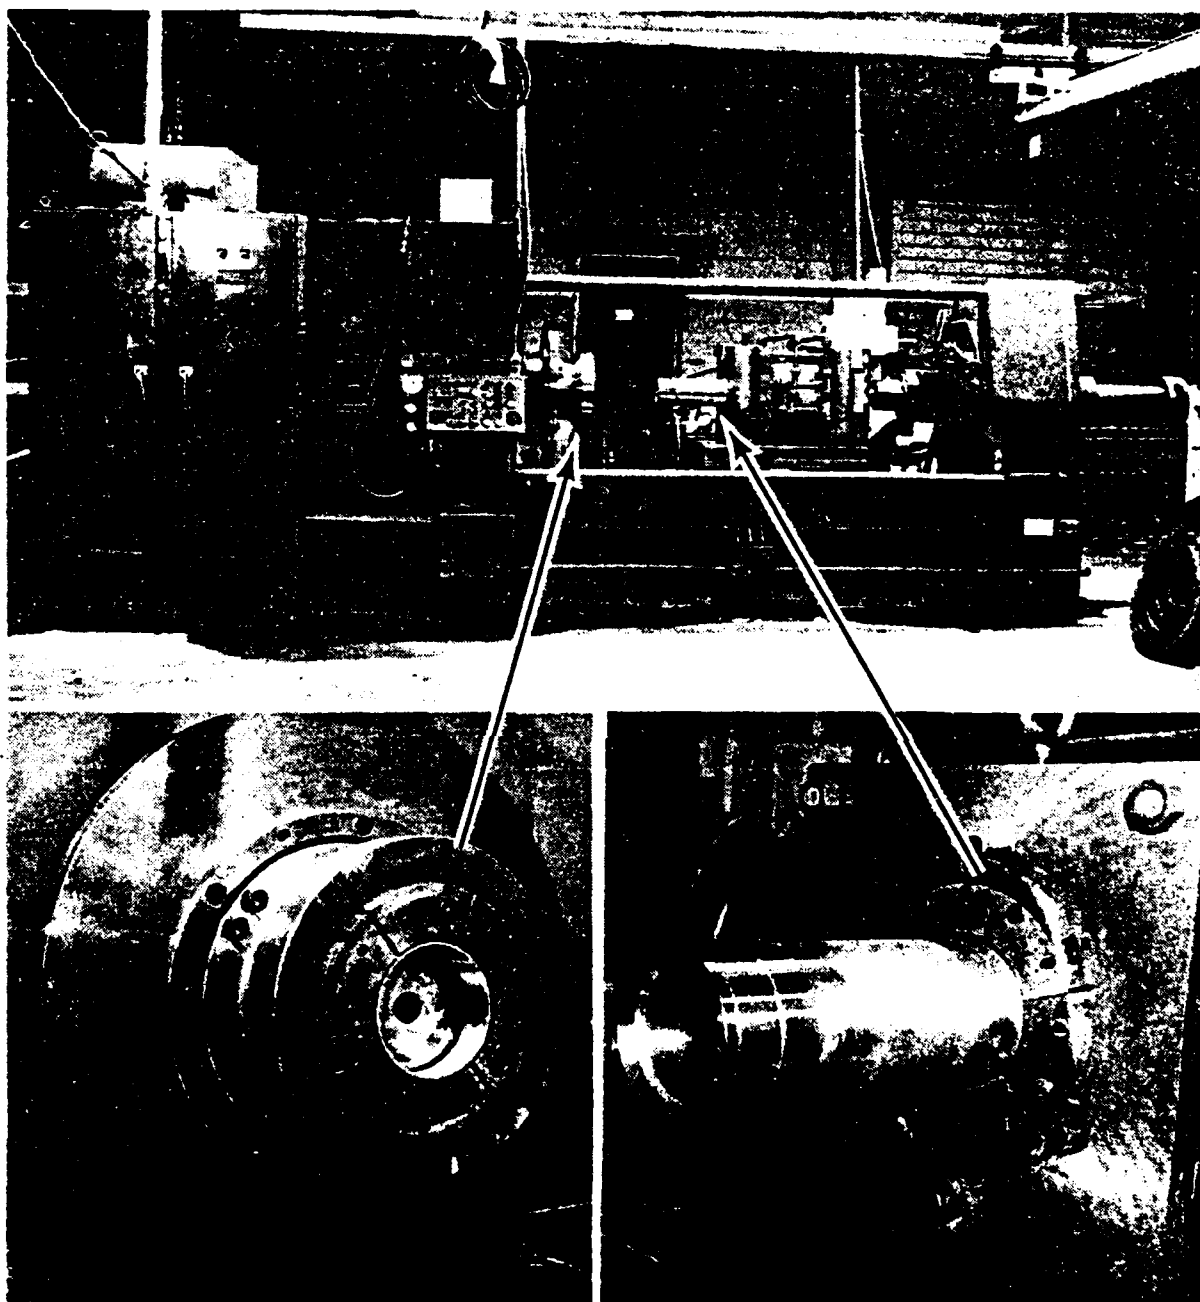
PHOTO NO. 10734

TOP: MODEL 250B INERTIA-WELDING MACHINE.

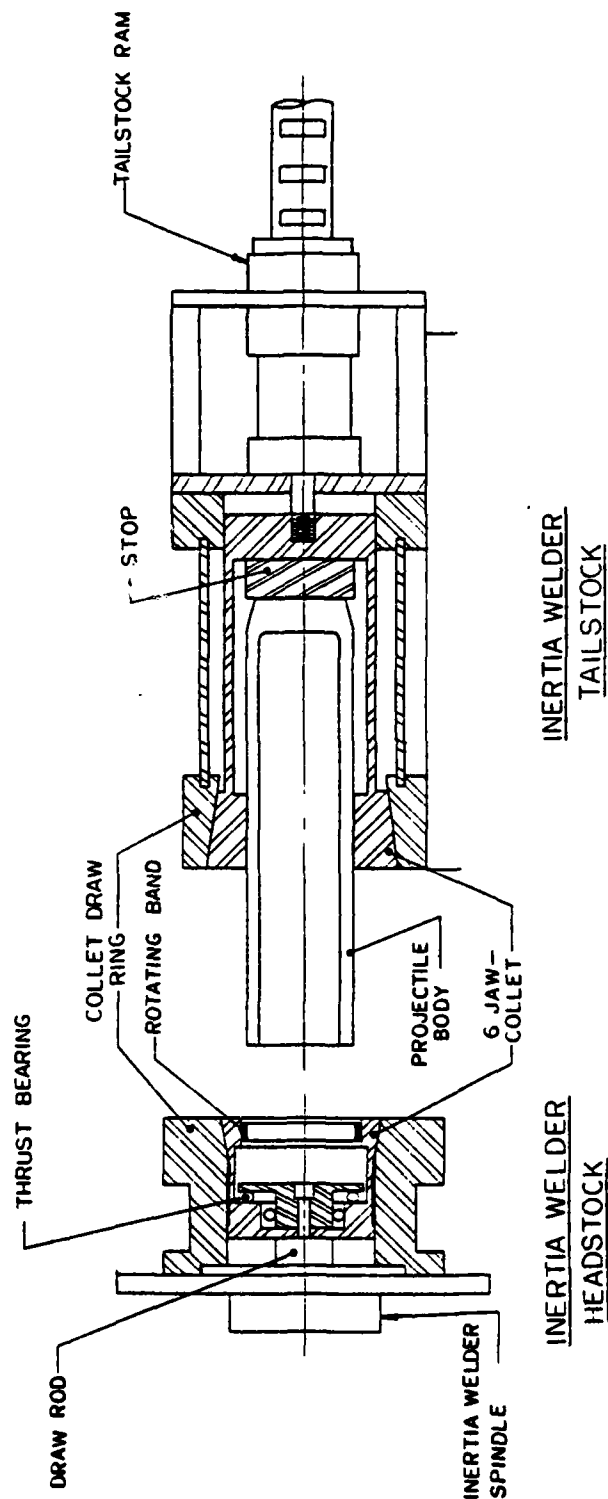
Illustration of Setup for Inertia Welding Rotating Bands to Projectile Body with a Radial Headstock Collet

A timer in the machine signals the tailstock to retract, releasing pressure on the thrust bearing assembly, and causing the headstock collet jaws to open. As the tailstock retracts, the banded body is extracted from the headstock collet to the load/unload position of the tailstock. Both collets now are ready for reloading of their respective parts to repeat the cycle. Additional drawings of the headstock collet are presented in the Appendix to show details of the mechanism.

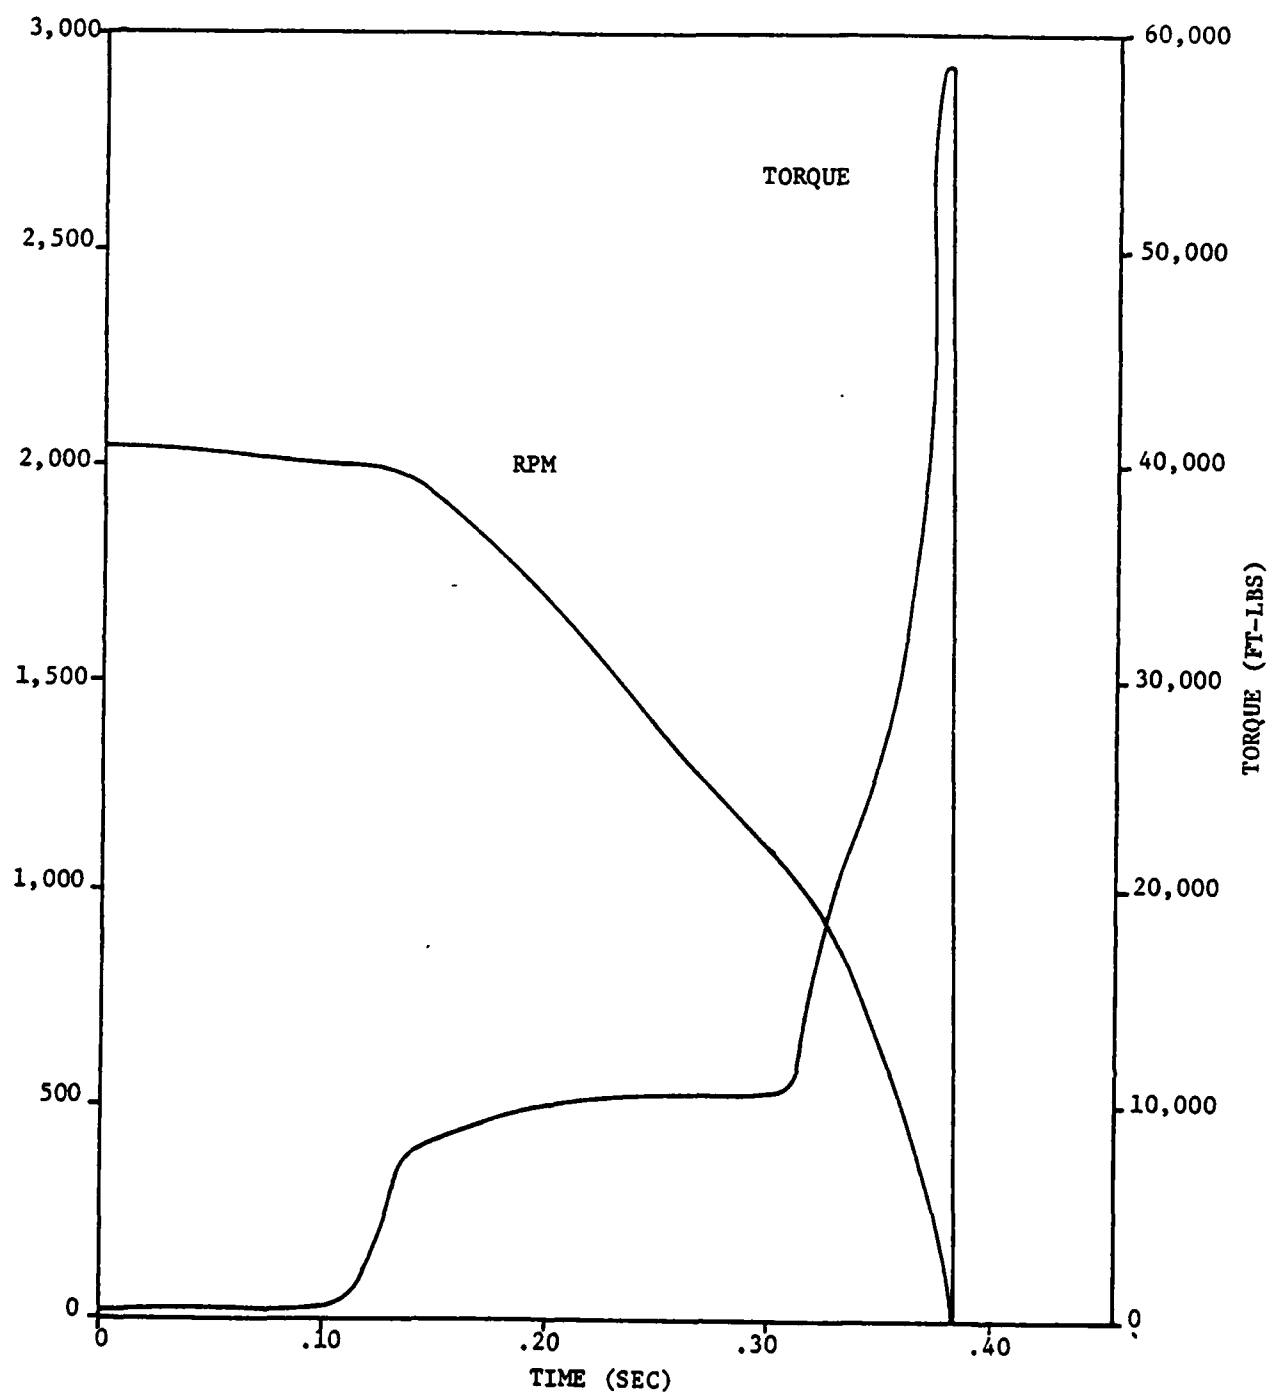
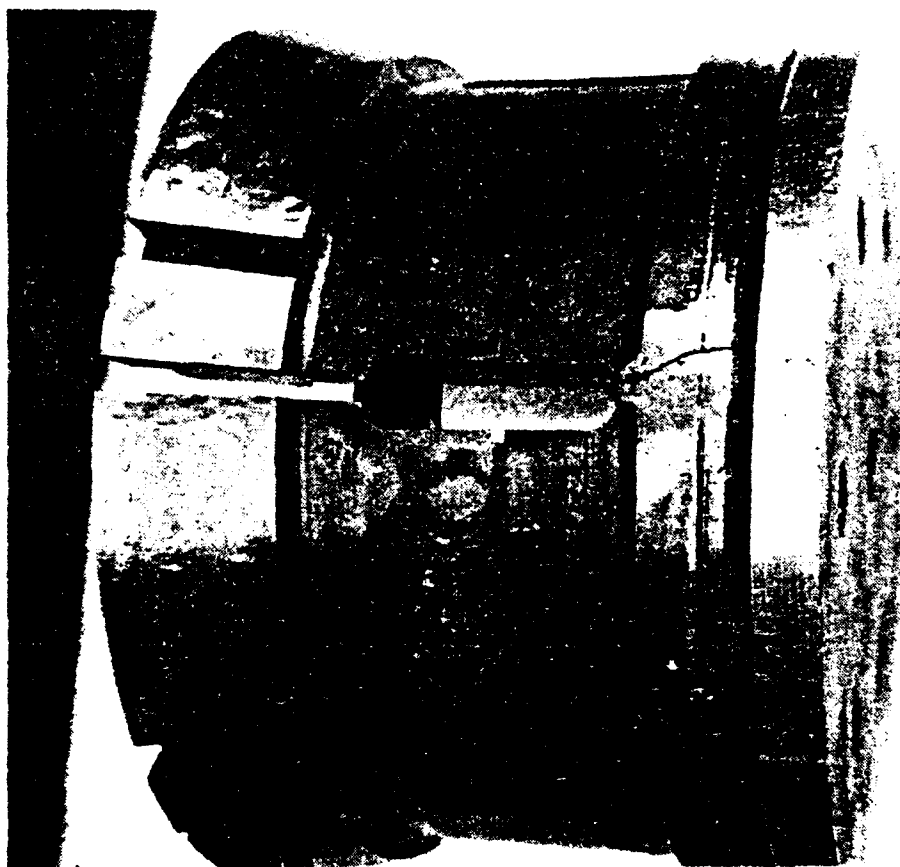
PHOTOGRAPH NO. 10710

COLLET SHOWING BREAK SUSTAINED IN THE ROOT OF THE TANG.

During the initial phase of the program, a considerable amount of tooling breakage occurred as a result of the peak torque load. A headstock collet was broken, as shown in Photograph No. 10710 on Page 17. A tailstock collet was also broken, as were a number of collet pads and retaining keys.

When a component did fail, it was redesigned to take into account the previously unexpected high loads that occur during the welding cycle. New materials were used when indicated, care was taken to minimize stress concentration areas, and heat treatment procedures were specified as needed. It is interesting to note that we have not had any failures in any of the redesigned hardware, and Chamberlain is confident that the current tooling design is adequate for its intended purpose.

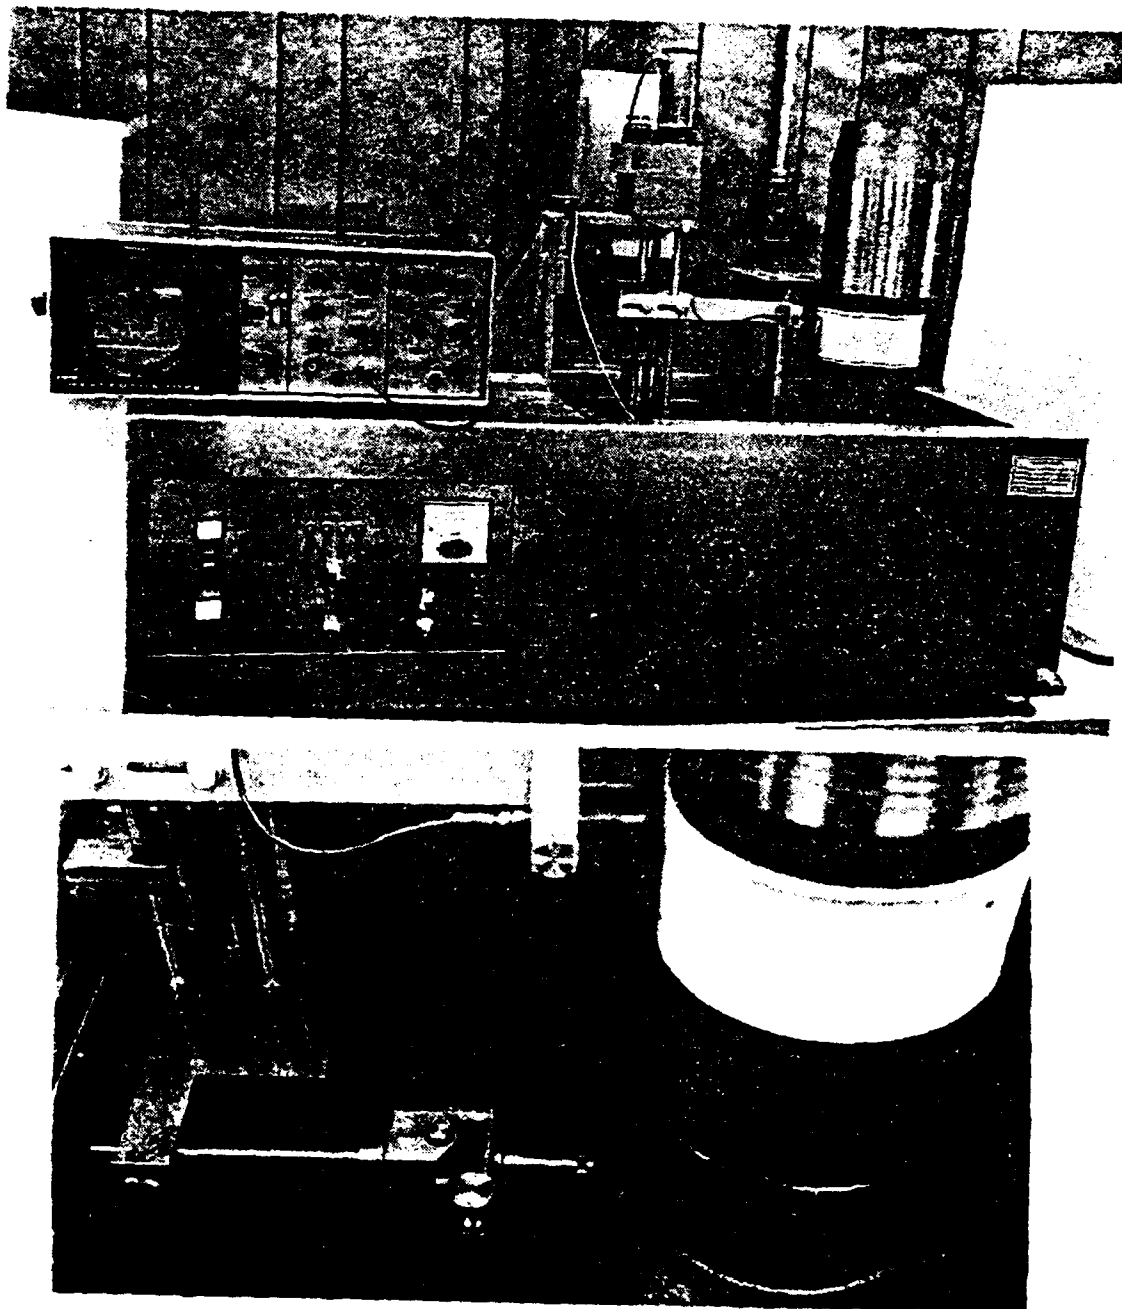
PHOTO NO. 10732

ULTRASONIC SCANNING EQUIPMENT--INSET: PROBE AT BOTTOM AND CHART
RECORDER AT TOP.

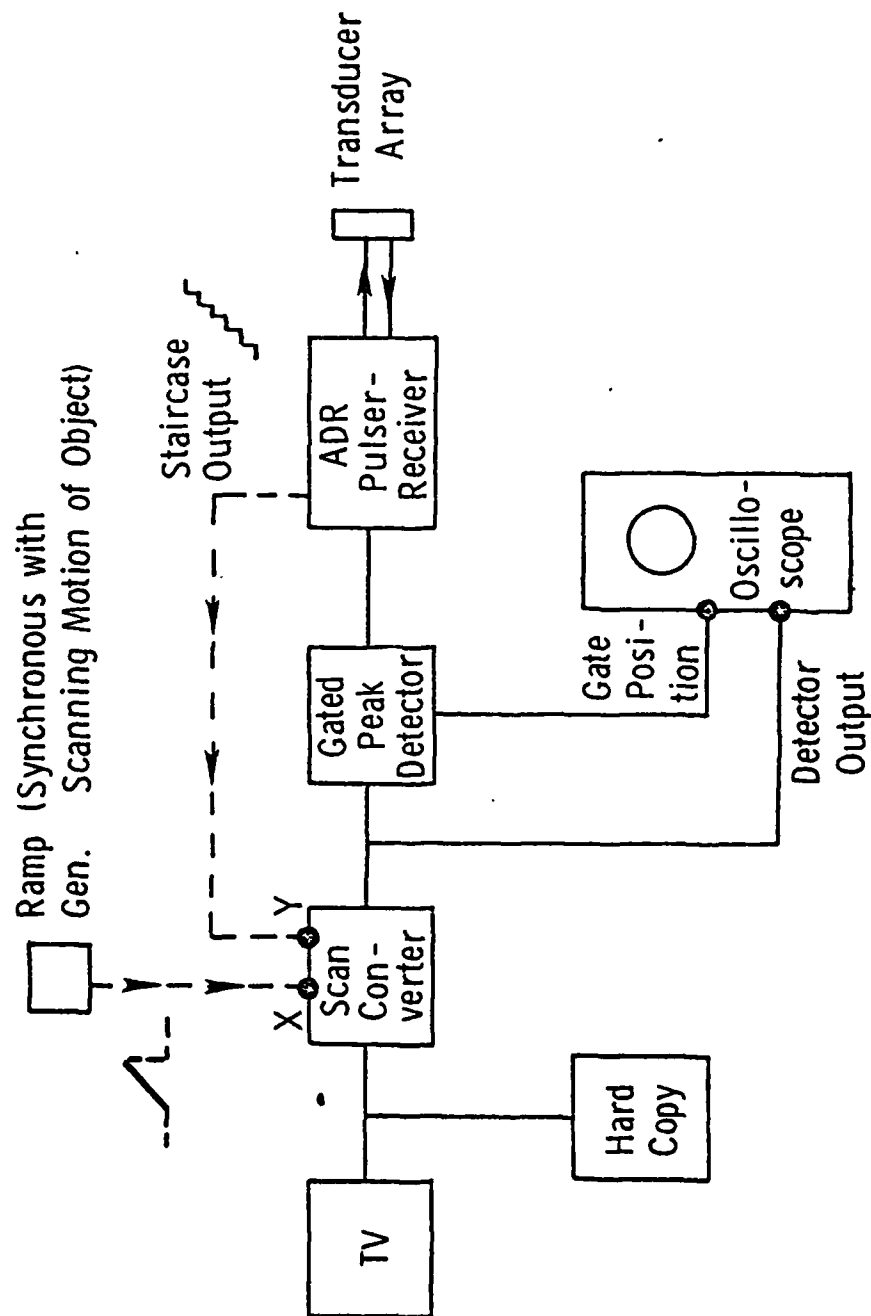
Block Diagram of Electronic System

The system can be used to test for disbond areas between a band and a shell by placing the transducer inside the shell or outside of it. Four elements of the phase array transducer operate at one time, and are sequenced automatically to the next higher element; i.e., elements number one through four are pulsed first then two through five, and then three through six, etc. All 64 elements are pulsed in 1/40 second. Each element is 0.055 inch wide and 0.4 inch long, so that when four elements are pulsed the activated area is 0.22 inch by 0.4 inch. The transducer elements operate at 5 MHz.

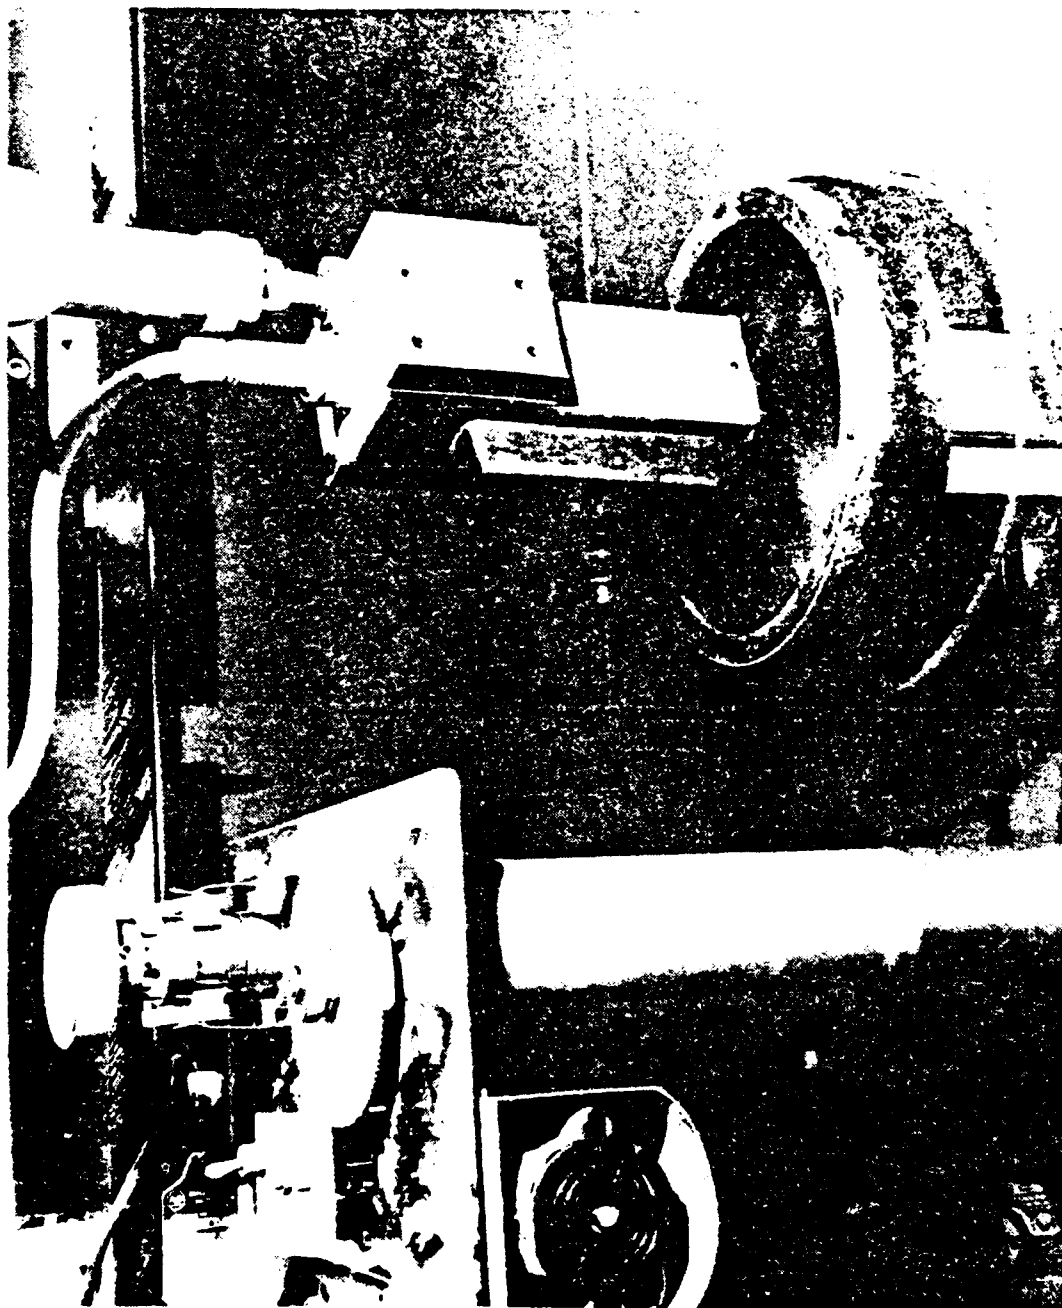
PHOTOGRAPH NO. 10840

TRANSDUCER HEAD BEING LOWERED INTO SAMPLE WELDED BAND

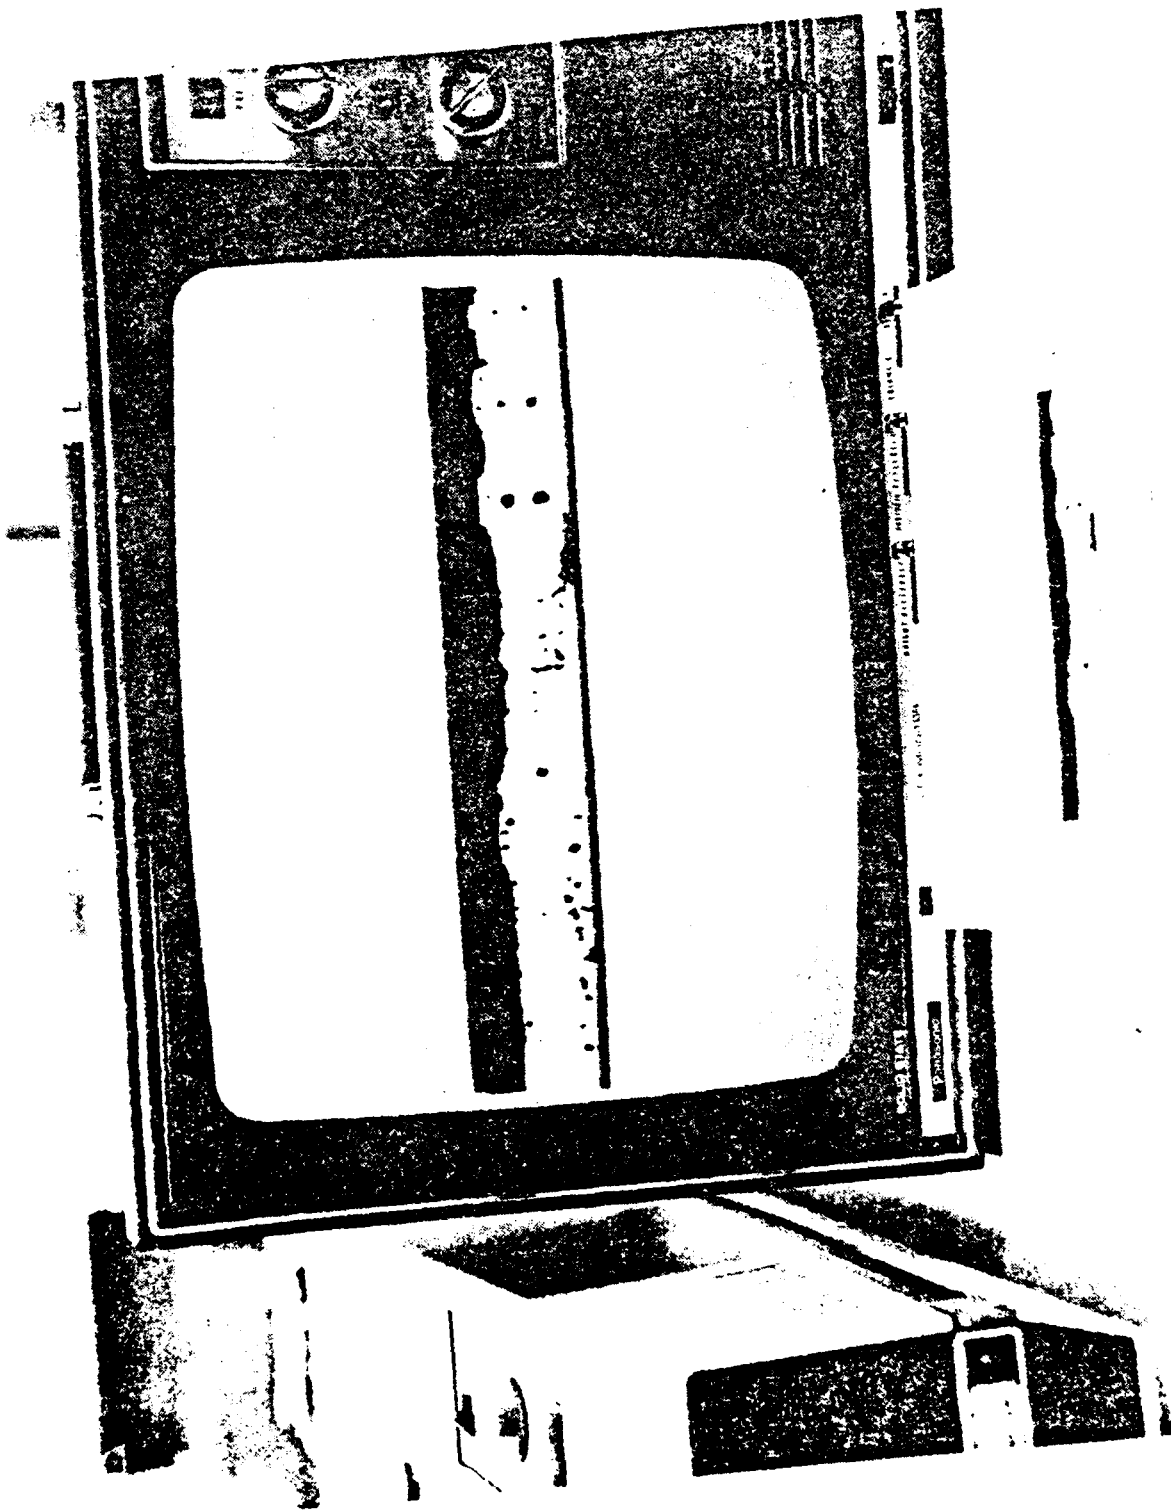
PHOTOGRAPH NO. 10841
PHASE ARRAY OUTPUT DISPLAY ON TV SCREEN AND ELECTROSTATIC HARD COPY.

4.2.2.2 The signal received from the transducer is processed electronically and is displayed on an oscilloscope screen as the scan is being taken, or imaged onto a TV screen, as shown by Photograph No. 10841, Page 33, when the scan is completed. The image is stored on a vidicon tube, which can hold the signal for as long as 12 hours. Using an electrostatic copier, a hard copy of the image can be made for a permanent record of the disbond areas in the welded band/shell interface. A particular area in the displayed image can be magnified on the TV screen for a closer examination.

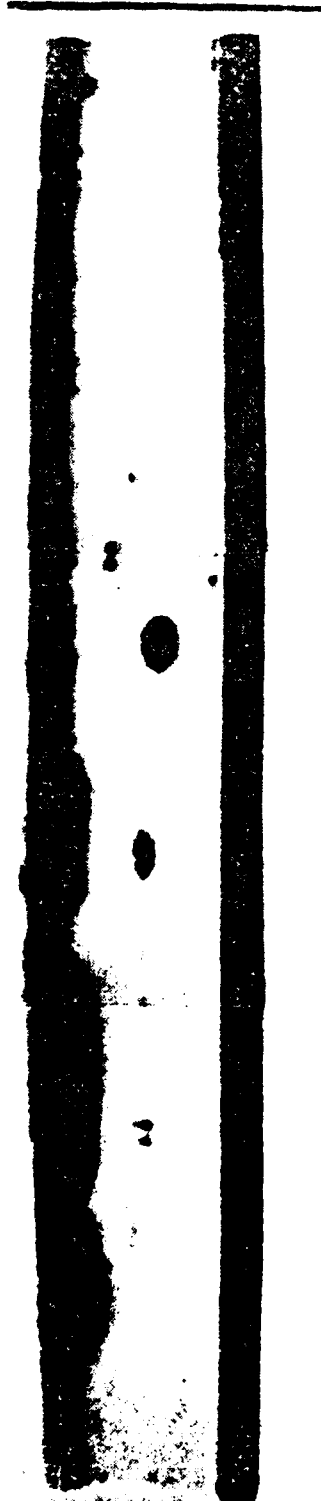
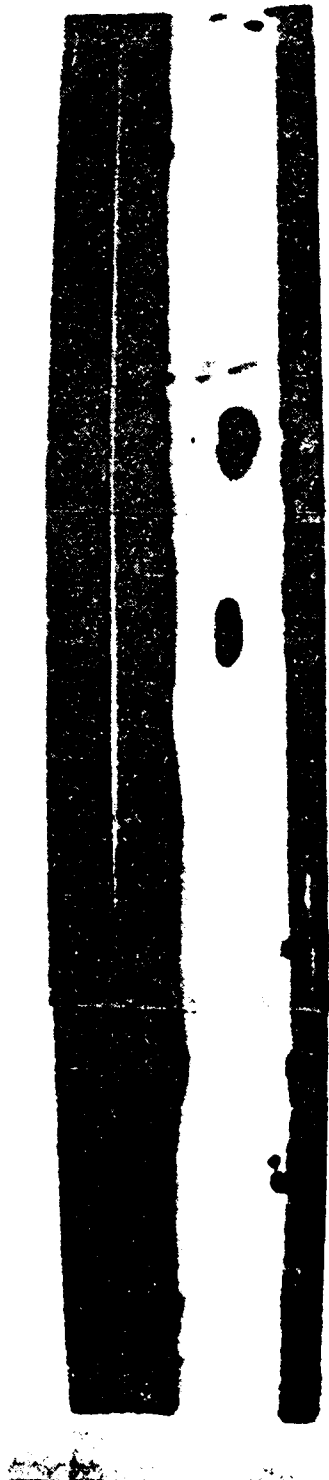
PHOTOGRAPH NO. 10842

Transducer Located Outside Shell

Transducer Located Inside Shell

SAMPLE 155-MM, M483 INERTIA WELDED SCAN FROM TEST EQUIPMENT AT U. S. ARMY
MATERIALS AND MECHANICS RESEARCH CENTER.

4.2.2.4 Samples of the 155-mm and 8-Inch inertia welded bands were used to compare the disbond areas obtained with their test equipment to those obtained with Chamberlain's equipment. On Page 34 are shown the patterns obtained with Chamberlain's equipment using a spherical focusing transducer and placing it outside the shell for testing for disbond areas in the weld joint. Photograph 10842 on Page 35 shows the results obtained using the equipment in Watertown. The patterns shown are Polaroid pictures taken from the TV screen (the electrostatic copier was not operating properly at the time). The top view shows the pattern when the transducer elements are located outside the shell, and the bottom view is when it is located inside the shell. The difference in the two patterns is due more to changing the resolution settings of the instrument than in actual differences between the two test methods. The results show that voids in the welded band/shell interface can be detected either by placing the transducer elements inside or outside the shell. Photograph No. 10843 on Page 36 is a magnification of one of the flaws shown by Photograph No. 10842 demonstrating the magnification capabilities of the TV monitor.

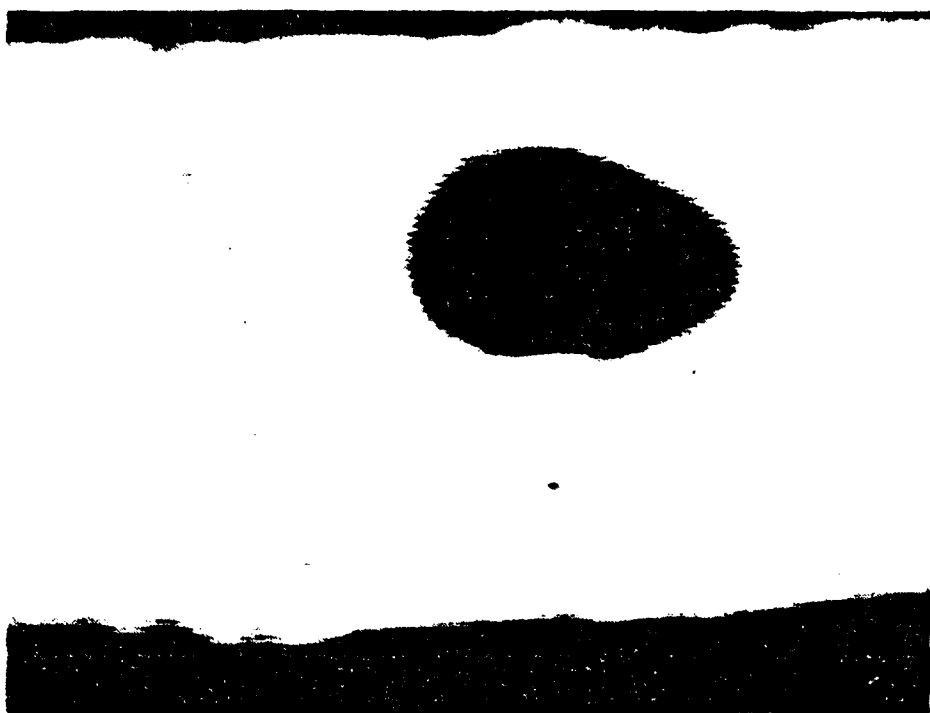
PHOTOGRAPH NO. 10843

MAGNIFICATION FROM TV MONITOR OF FLAW IN INERTIA WELDED BAND
ON 155-MM SAMPLE

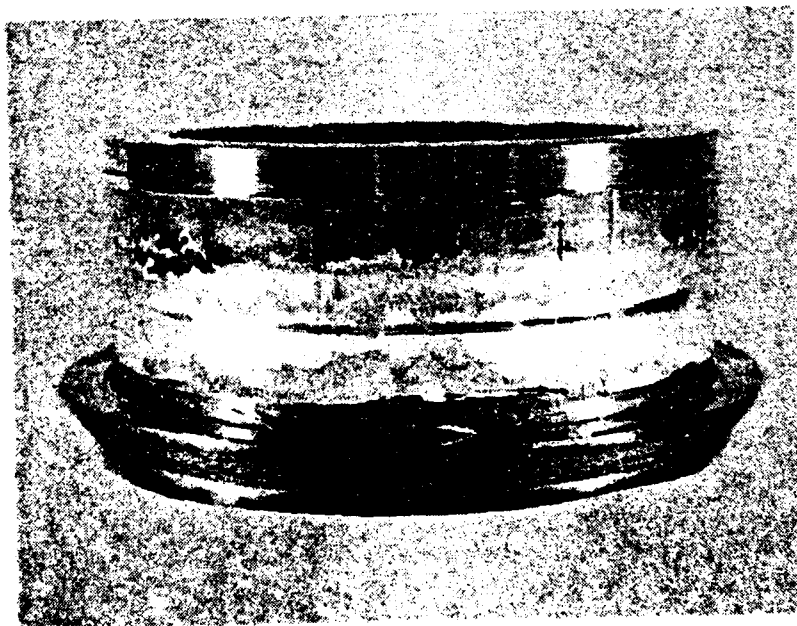
The complete band was sheared on five test specimens. A photograph of one of these is shown below. These bands were sheared in a 250-ton press. The average force required to shear these bands was 468,000 pounds. This represents an average stress on the weld area of about 14,000 psi. However, the

Band Shear Test Speciman

weld did not fail initially. The band flowed and spread and sheared through the band material until it was more than half sheared. At this point the weld began to fail, but the weld area supporting the load had been reduced to less than 1/2 the original area. This being the case, the weld stress had reached at least 30,000 psi, and it can be expected to fail in this region. It seems fair to conclude that the weld essentially is as strong as the band material itself.

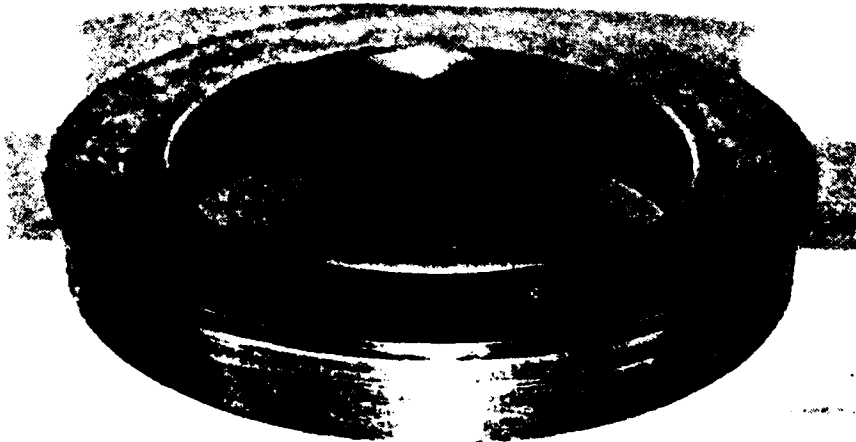
4.3.2.1 Dye penetrant examinations were conducted on both 105-mm and 155-mm projectiles after the bands were inertia welded in place. Our method was to examine an entire projectile body-band interface. Projectiles were machined to present a flat, shear interface at the forward end of the band -- use Photograph No. 10736 on the following page as a reference to how a recent banding appears before machining down into the projectile to expose the interface. We then cleaned the faced-off band area with Zyglo ZC-7 cleaner and sprayed on Zyglo AC-22 dye penetrant. The penetrant was left to work for one-half hour. We then cleaned the surface with ZC-7 cleaner and sprayed on Zyglo ZP-9 developer and subjected the surface to ultraviolet light to determine if any of the dye penetrated the interface between the band and body. After the examination was completed, we machined away .100 inch to present a new interface surface and repeated the process until the entire band area was machined away (See photograph below).

Specimen for Dye Penetrant Examination

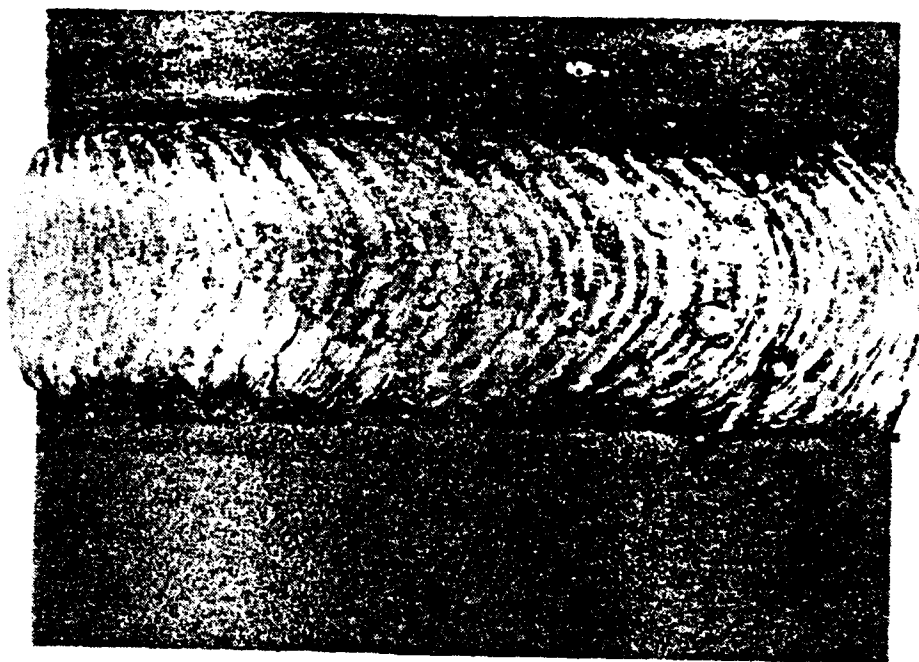
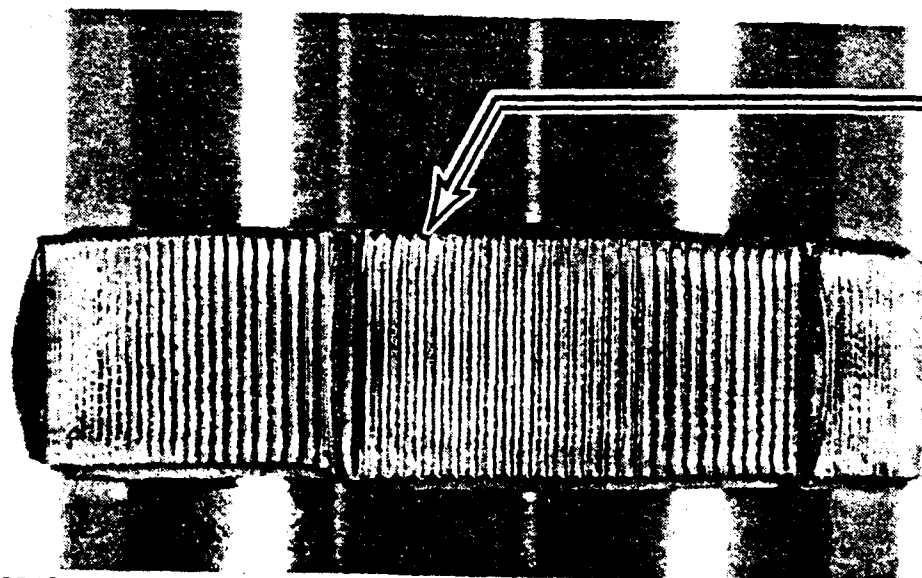
PHOTOGRAPH NO. 10736

Start Facing
Here for Dye
Penetrant
Examination,
.100 Inch
Increments

TYPICAL MIG-WELDED ROTATING BAND (TOP) AND INERTIA-WELDED ROTATING BAND (BOTTOM) IN AS-WELDED CONDITION.

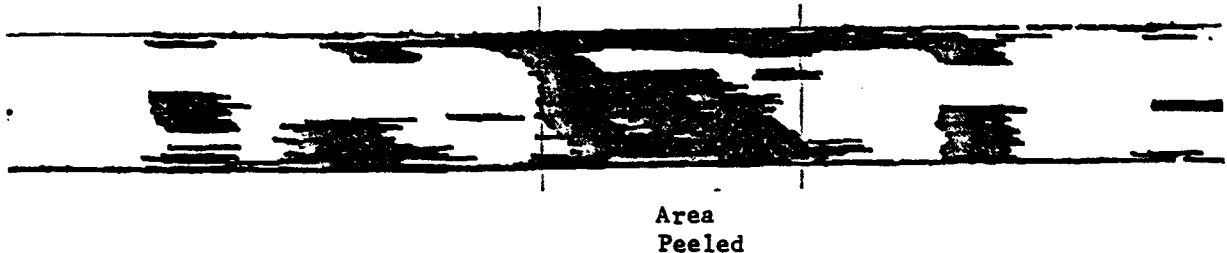
4.3.3.1 Another method used to establish correlation between ultrasonic scanning and actual disbond was to mechanically peel sections of the band from the projectile body and compare the bonded areas with those indicated on the ultrasonic scan. Specimen No. 39 had a particularly poor weld because the band slipped in the collet. The ultrasonic scan for this weld is shown below. This specimen was selected for the "peel test" since the large unbonded areas would make it easier to remove the band sections. The area of the band that was removed is indicated in the photograph which represents a length on the circumference of the band of about four inches. The

Ultrasonic Scan of Specimen No. 39

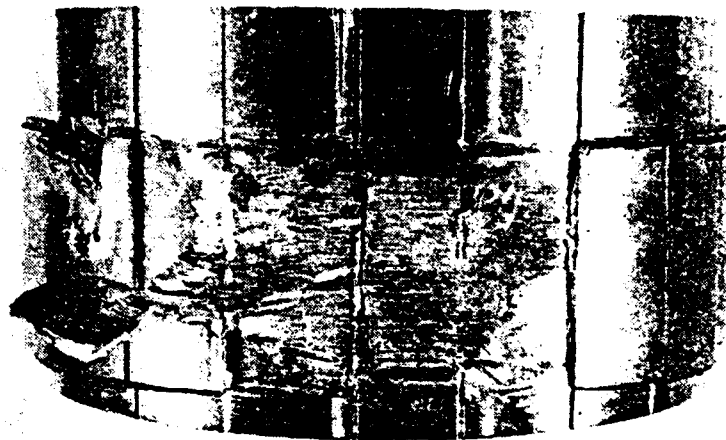
band was slit longitudinally into sections about one-inch wide, and these sections were chiseled from the steel surface. The bonded areas could be determined by the difficulty encountered when removing the strips, and by the surface texture of the material at the separation plane. The bonded areas compared very well with the ultrasonic record. A photograph of the specimen is shown on the following page. This test is only applicable to gross defect determination.

Photograph of Specimen No. 39 Showing Peeled Sections

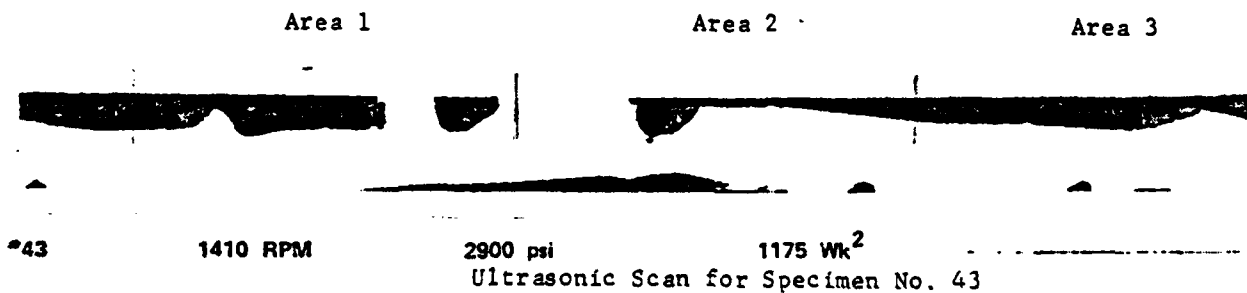
4.3.3.2 Perhaps the most revealing method for comparing the ultrasonic scans with actual results is to turn the band in a lathe until only a thin layer about .005 inch thick, is left on the steel. This foil layer can easily be peeled from the steel in areas where it is not welded, and these areas can be compared with the ultrasonic scan. This has been done on several specimens, and photographs of a typical specimen are included. Below is a copy of the ultrasonic scan for Specimen No. 43.

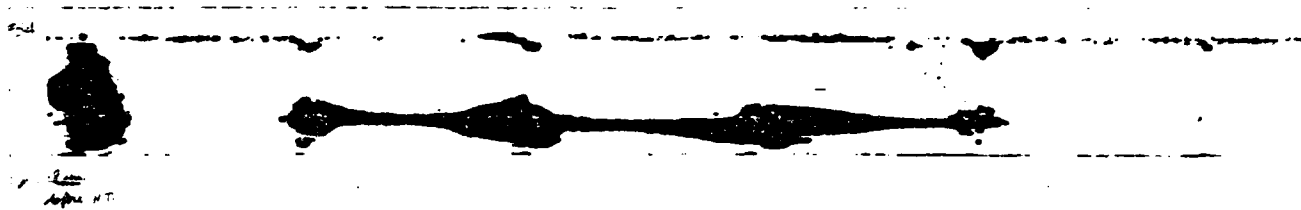
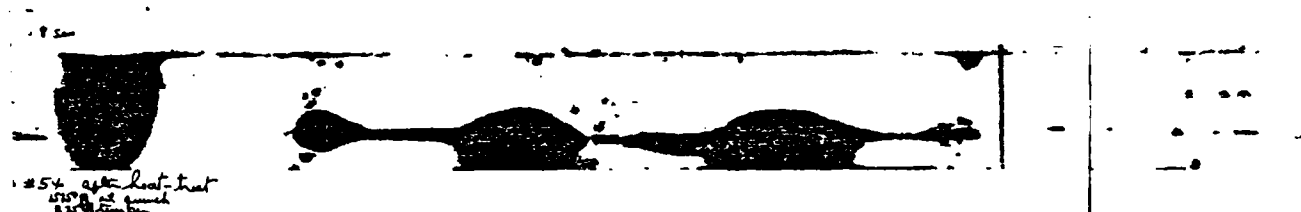
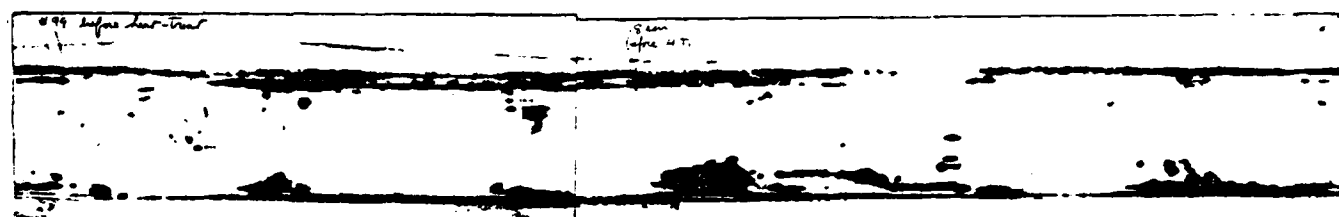
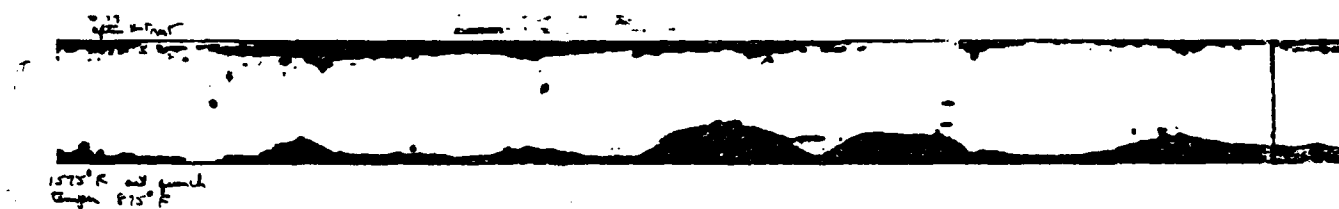
PHOTOGRAPH NO. 10939

BAND 54: BEFORE HEAT TREATMENT
.8 SENSITIVITY

BAND 54: AFTER HEAT TREATMENT
.8 SENSITIVITY; 1,575° F OIL QUENCH; 875° F TEMPER

BAND 99: BEFORE HEAT TREATMENT

BAND 99: AFTER HEAT TREATMENT
1,575° F OIL QUENCH; 875° F TEMPER

TWO M483A1 INERTIA WELDED BANDS FROM GROUP PROCESSED BEFORE
FINAL PARAMETERS WERE ESTABLISHED. HEAT TREATMENT INCREASES
ANY PREVIOUS DISBOND INDICATION.

2.5 The production heat treatment operation conducted after banding was found to enlarge areas of disbond at the band-body interface, but did not seem to adversely affect areas where good welds were achieved.

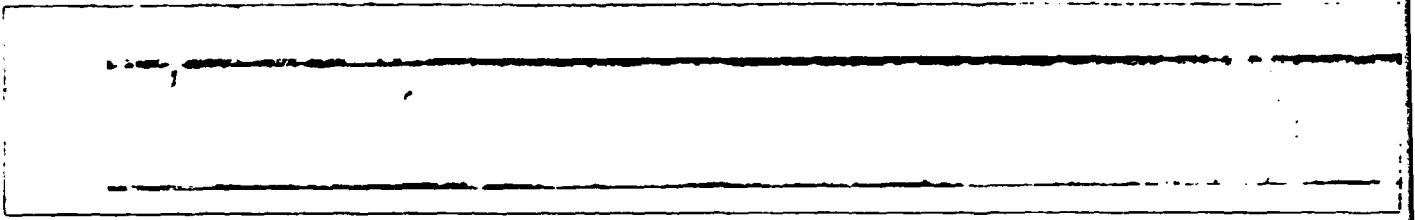
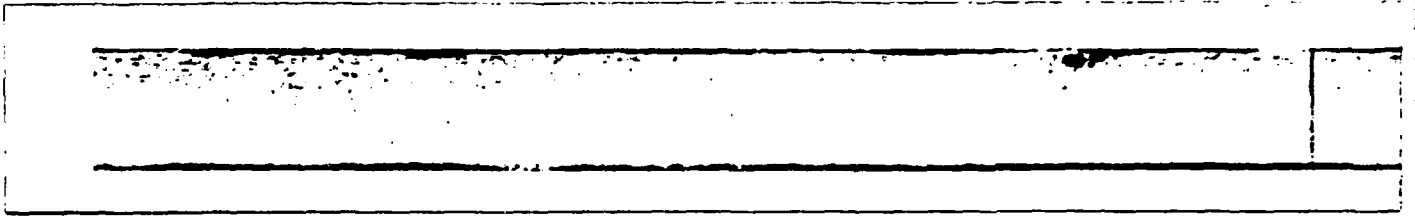
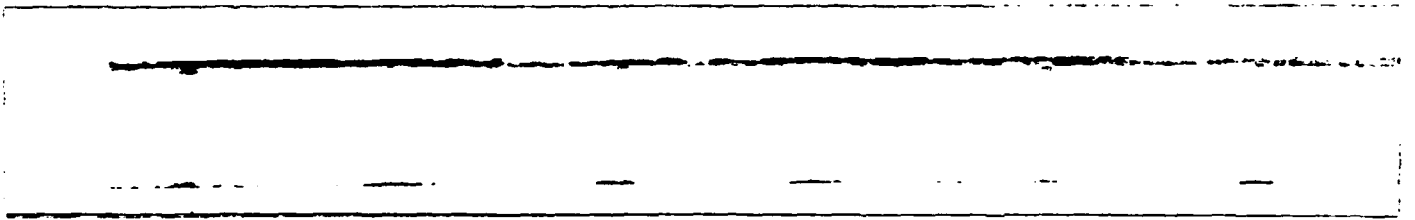
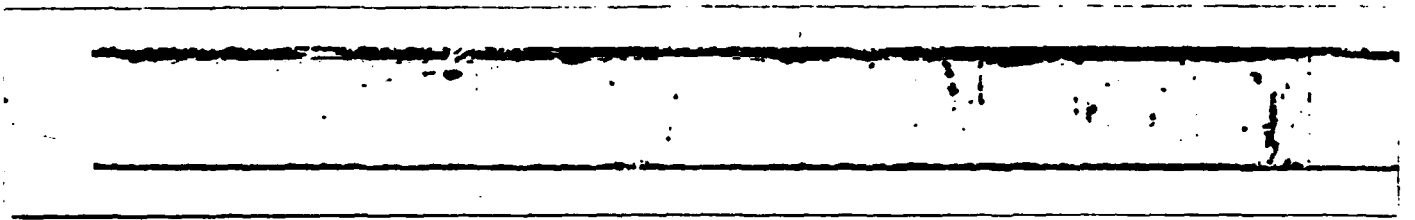
PHOTOGRAPH NO. 10787

BAND 77-191: BEFORE HEAT TREATMENT

BAND 77-191: AFTER HEAT TREATMENT

BAND 77-225: BEFORE HEAT TREATMENT

BAND 77-225: AFTER HEAT TREATMENT

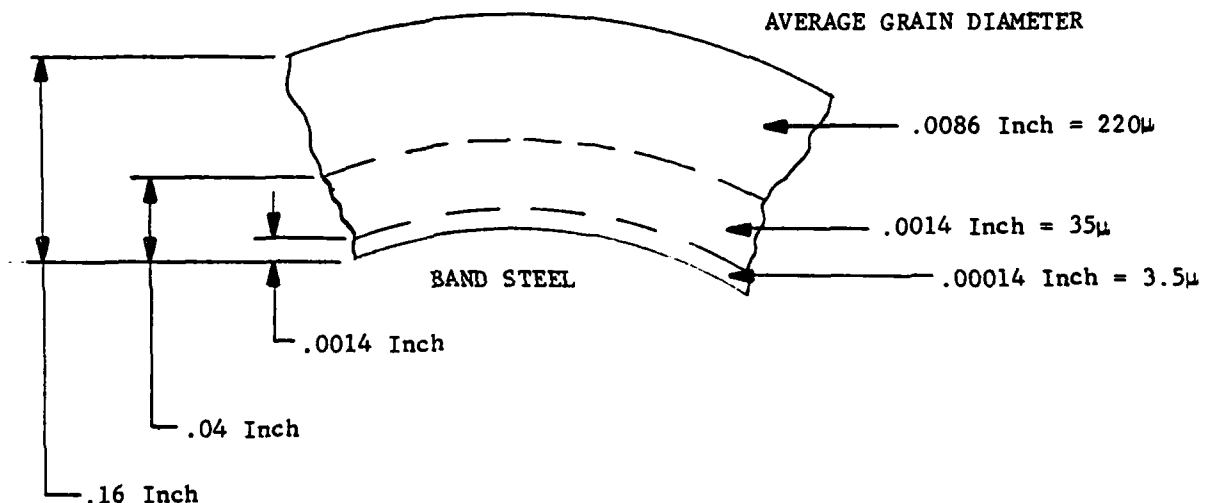
PROJECTILE 58
AS WELDED, EARLY PROCESS

The cold deformation and heating during welding were sufficient to cause recrystallization in the band for about .040 inch from the interface. The heavier deformation very near the interface gave a very fine grain size. Slight grain growth may have occurred in the region beyond .040 inch from the interface.

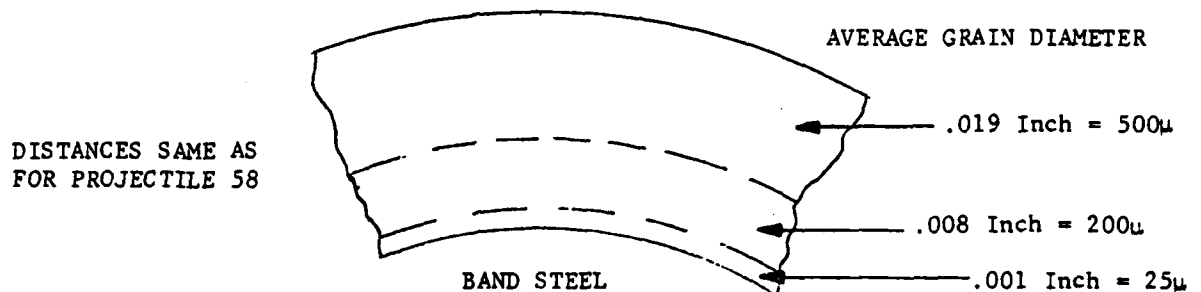
PROJECTILE 49
WELDED, EARLY PROCESS, HEAT TREATED

The grains in all three zones grew; there was significant annealing as shown by the decrease in hardness presented previously.

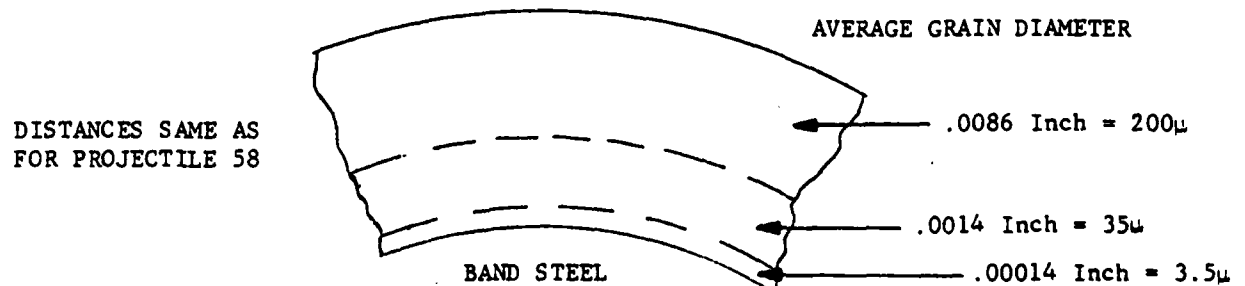
PROJECTILE A
AS WELDED, CURRENT PROCESS

Same observations as for Projectile No. 58.

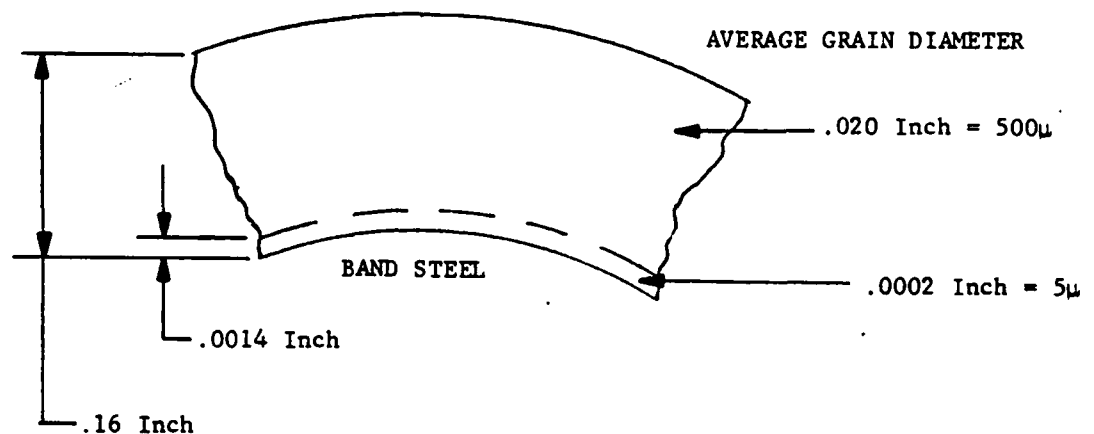
PROJECTILE 204
WELDED, CURRENT PROCESS AND HEAT TREATED

Grain growth and softening; the only difference from Projectile 49 is that the intermediate grain size region does not remain. Generally we concluded that there is slight grain growth in the band, but not enough to affect the ultrasonic scanner.
